# **CCIT - Container Closure Integrity Testing following USP 1207**

**Tony Stauffer/ Tatiana Simental CCIT s.a./Pti**

# CCIT - New USP 1207 guidance document

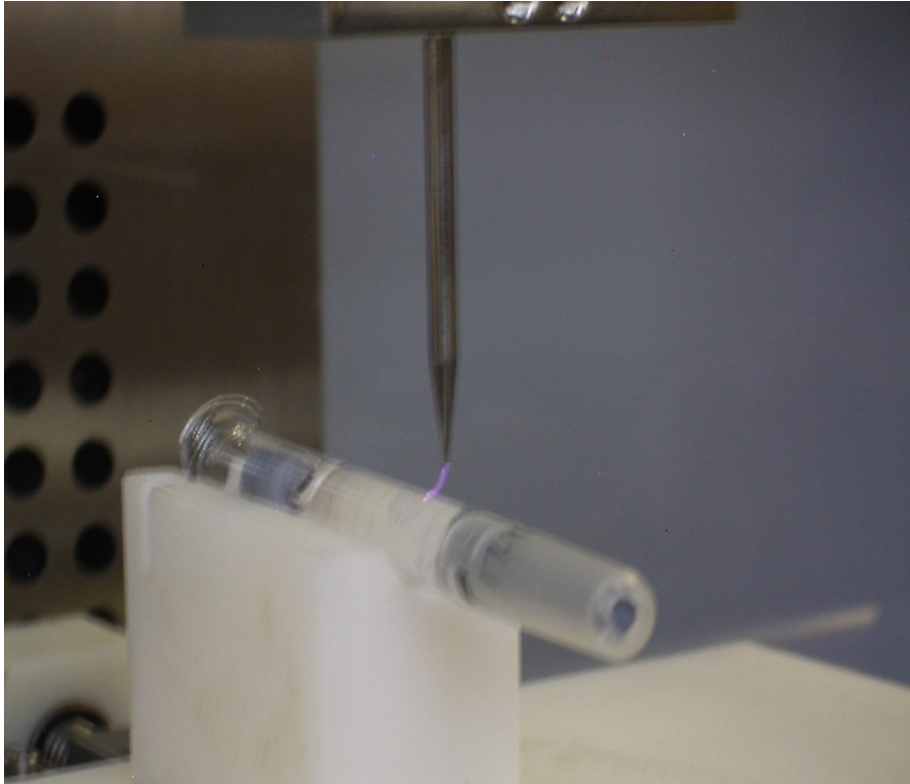
- Signal Detection 20ml Vial – Integrator – Signal has amplitude changes
- High Voltage:16kV
- **Red - 3.6um leakage**
- **Black sample without defect**
- **350 RPM, 5mm/s, filled with distilled water**

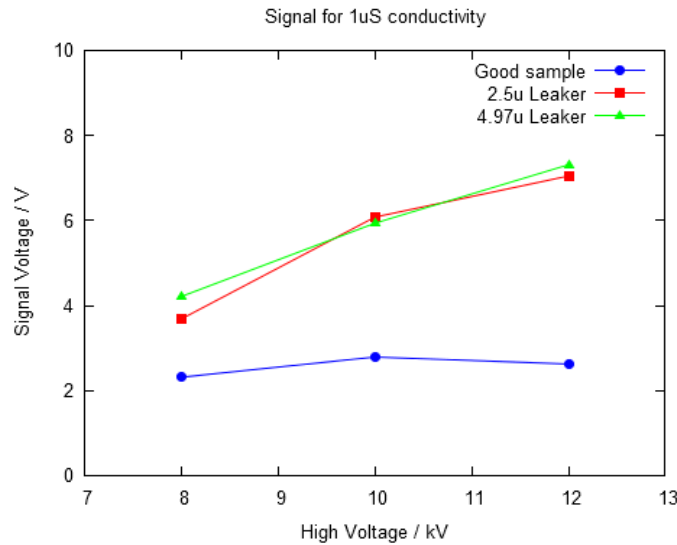
# High Voltage - Technology Comparison

( distilled Water w/ 1ml Syringe )

Conventional HVLD	E-Scan 655 ( HVLD <sup>mc</sup> )
Product Exposure	7,000V with 18.5kV input	300V with 18.5kV input
Ozone production	0.305ppm ozone in 1 minute	0.004ppm ozone in 10 minutes

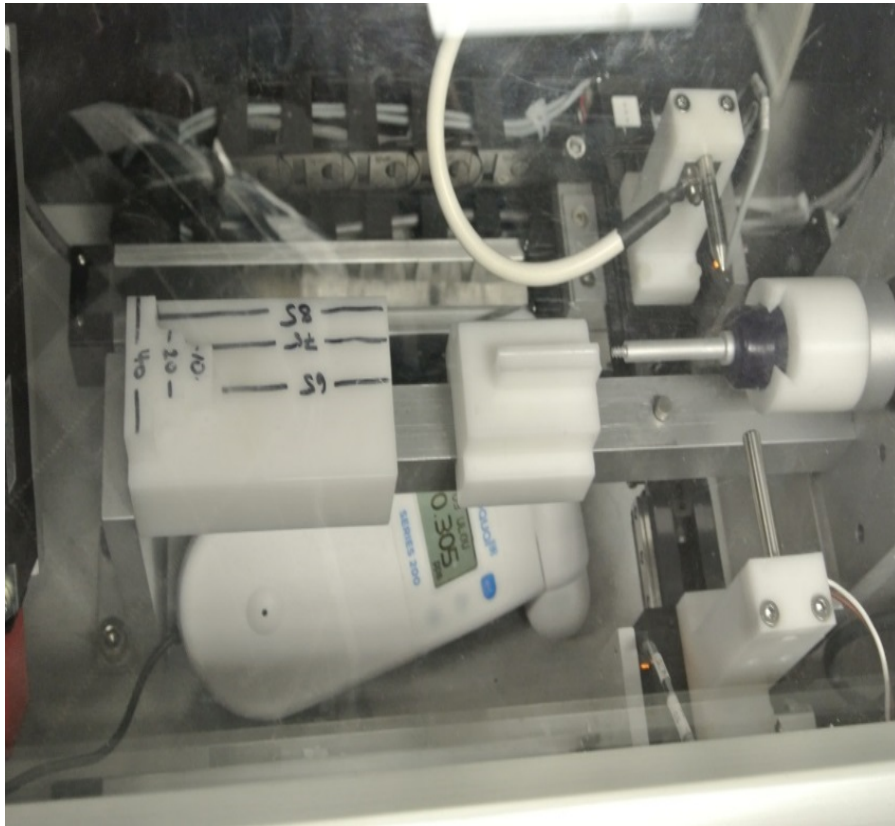
**HVLD - 0.305ppm Ozone  
after 1 min**

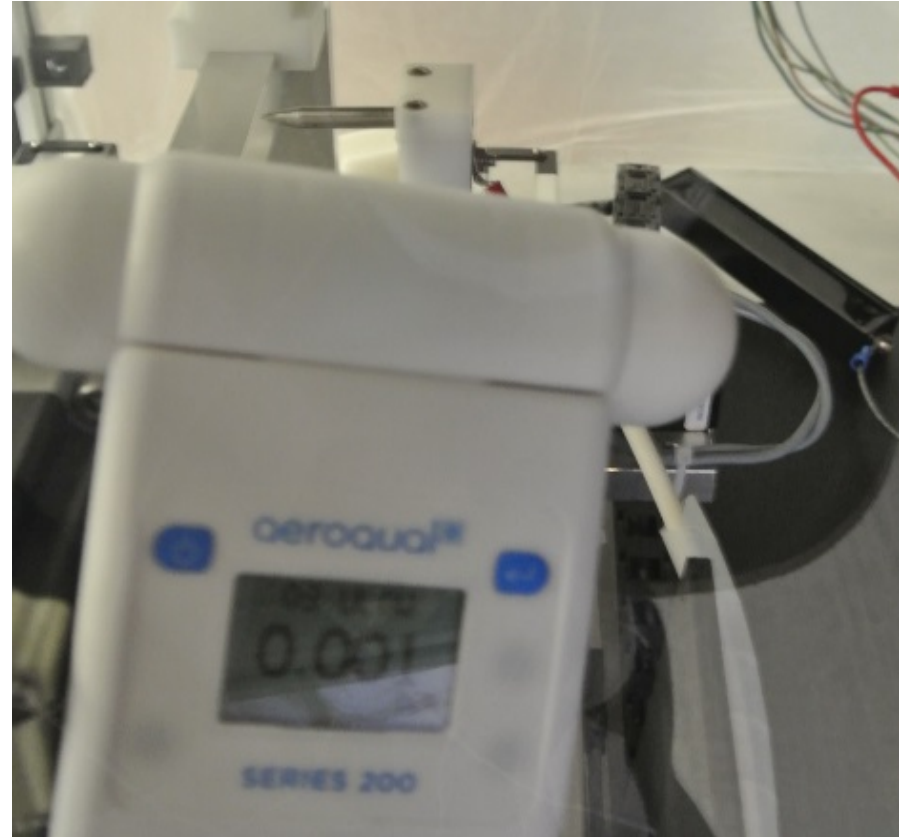
**HVLD<sup>mc</sup> – 0.001ppm Ozone  
after 6 minutes**

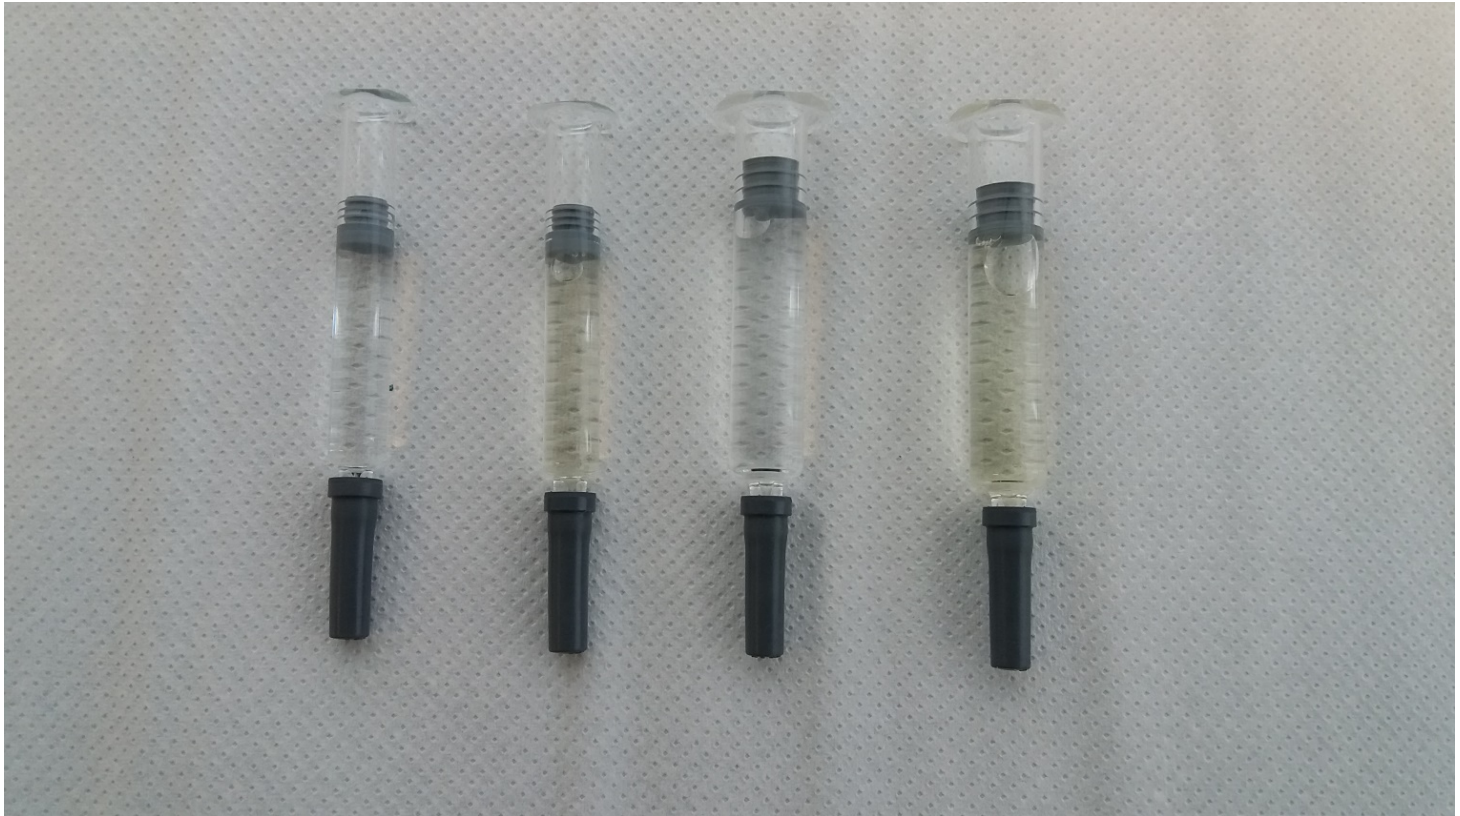
# Feasibility Study – PFS Samples tested

- 1 ml and 2.25 ml syringes
- Prefilled with H<sub>2</sub>O and Albumin (175 mg/ml, Cp  $\approx$  2.5)

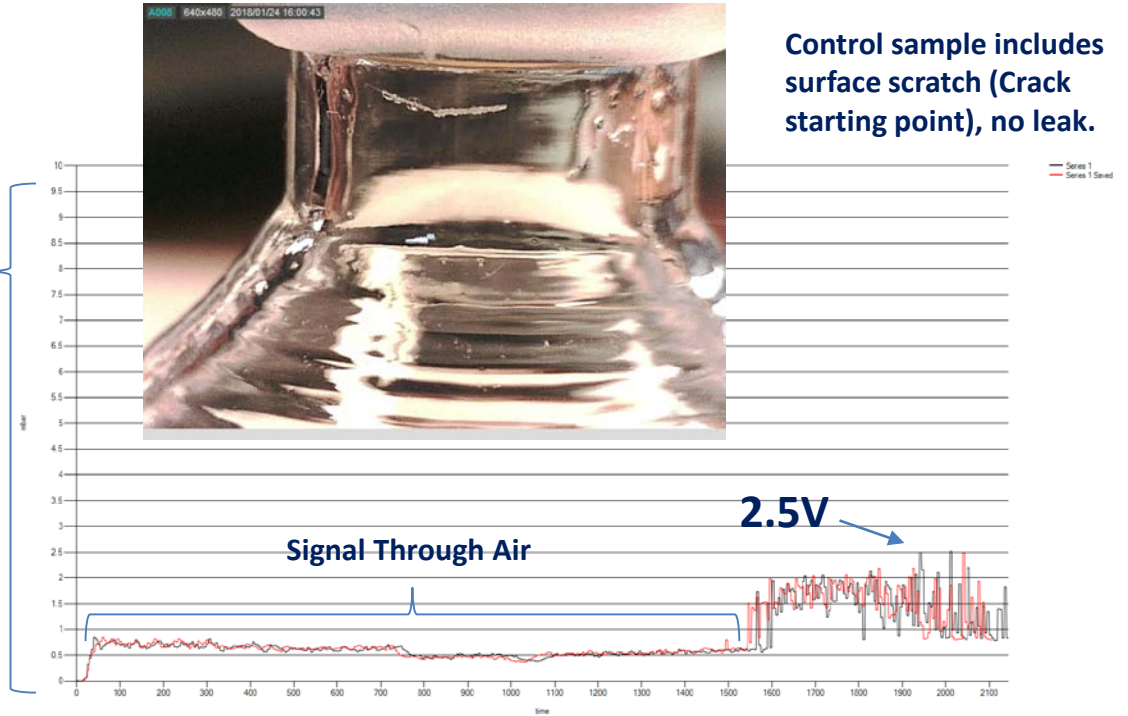
**0-10V  
Range**

Controlled crack produced.  
 Certified flow measurement with Helium mass spec.  
 Peak signal response is recorded.  
 Voltage signal response with each rotation.

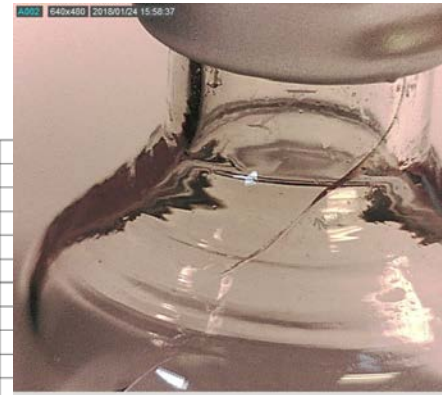
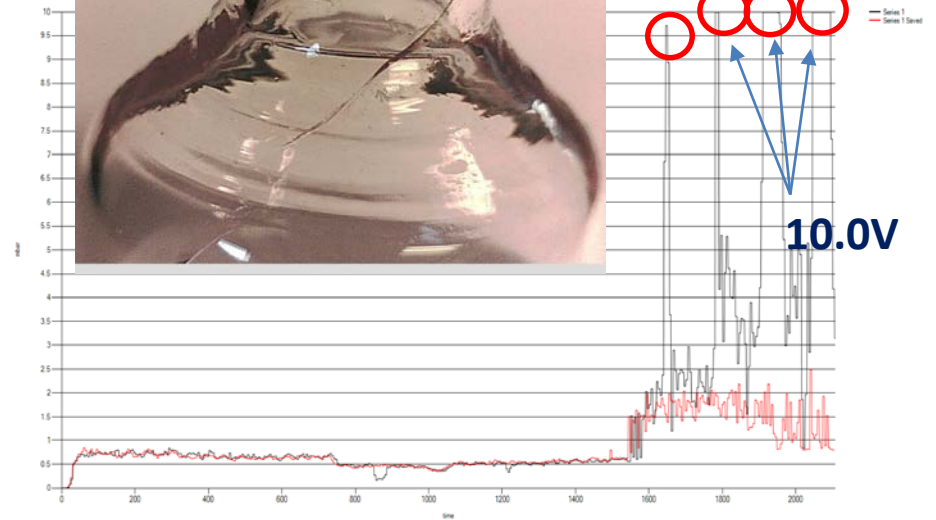
**Sample 1**

He Certified Leak Rate	
95.0	10 <sup>-5</sup> mbar·l/s
0.05700	sccm
2.67	~μm

Sample	leak rate			Visual	Size um
	mbar·l/s	10 <sup>-5</sup> mbar·l/sec	sccm		
1	0.00095	95	0.05700	Large crack	2.67
2	0.0000021	0.21	0.00013	Medium crack	0.13
3	0.000014	1.4	0.00084	Medium crack	0.32
4	0	0	0.00000	Small Scratch	0.00
6	0.00067	67	0.04020	Large crack	2.24
7	0.015	1500	0.90000	Large crack	10.61
9	0.00000029	0.029	0.00002	Small crack	0.05
10	0.00029	29.0	0.01740	Large crack	1.47
11	0.074	7400	4.44000	Large crack	23.56
12	0.055	5500	3.30000	Large crack	20.31
16	0.0014	140	0.08400	Small crack	3.24
18	0	0	0.00000	Small Scratch	0.00
19	0	0	0.00000	Small Scratch	0.00
20	0.016	1600	0.96000	Large crack	10.95

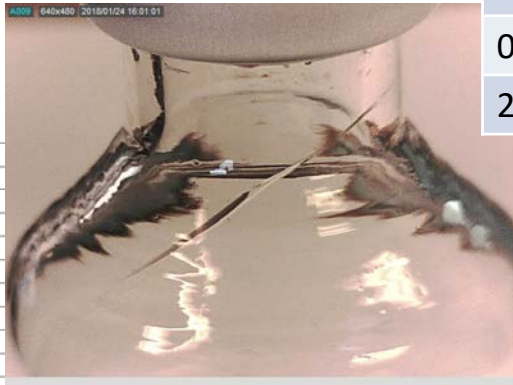
**Sample 6**

**He Certified Leak Rate**

67.0	$10^{-5}$ mbar·l/s
0.04020	sccm
2.24	~ $\mu$ m

**10.0V**

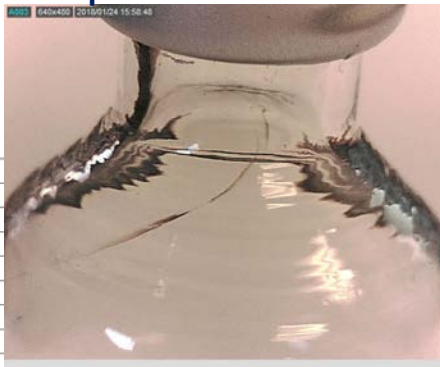
**Sample 2**

He Certified Leak Rate	
0.21	$10^{-5}$ mbar·l/s
0.00013	sccm
0.13	~ $\mu$ m

**10.0V**

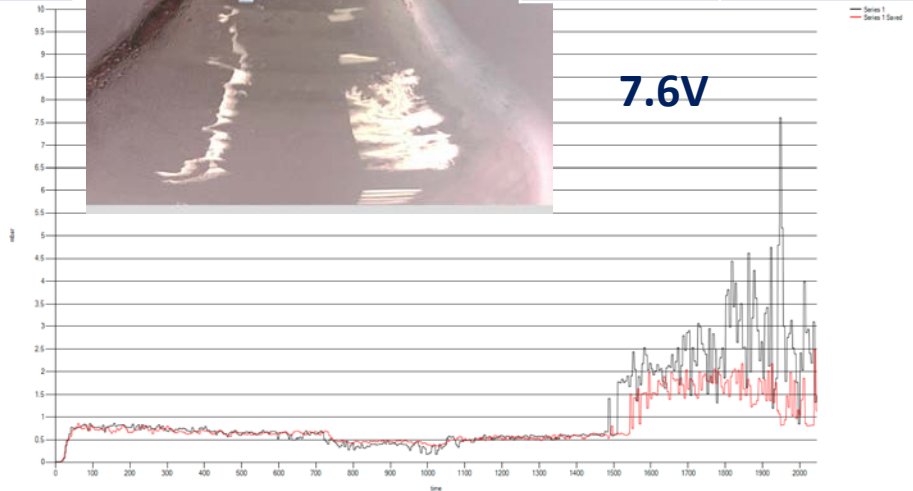
**Sample 3**

He Certified Leak Rate	
1.40	$10^{-5}$ mbar·l/s
0.00084	sccm
0.32	~ $\mu$ m

**7.6V**
