# High Voltage Leak Detection (MicroCurrent). HVLD<sup>MC</sup>

- Case Study: HVLD with Albumin Solution
- Case Study: HVLD Vs. Vacuum Decay with Albumin Solution

Amor Chabchoub  
CCIT Application Engineer  
PDA, Gothenburg 2023

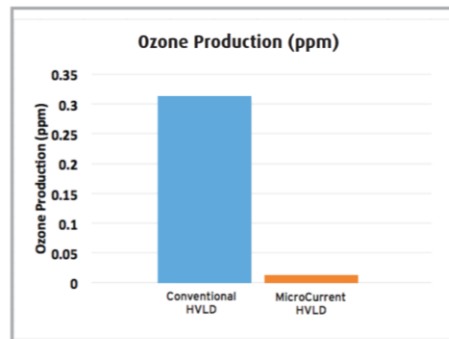
## Ozone Creation

10 minutes test  
Outside the product

Conventional HVLD	MicroCurrent HVLD
Exposure Voltage (V)	7000	300
Ozone Production (ppm)	0.305	0.006

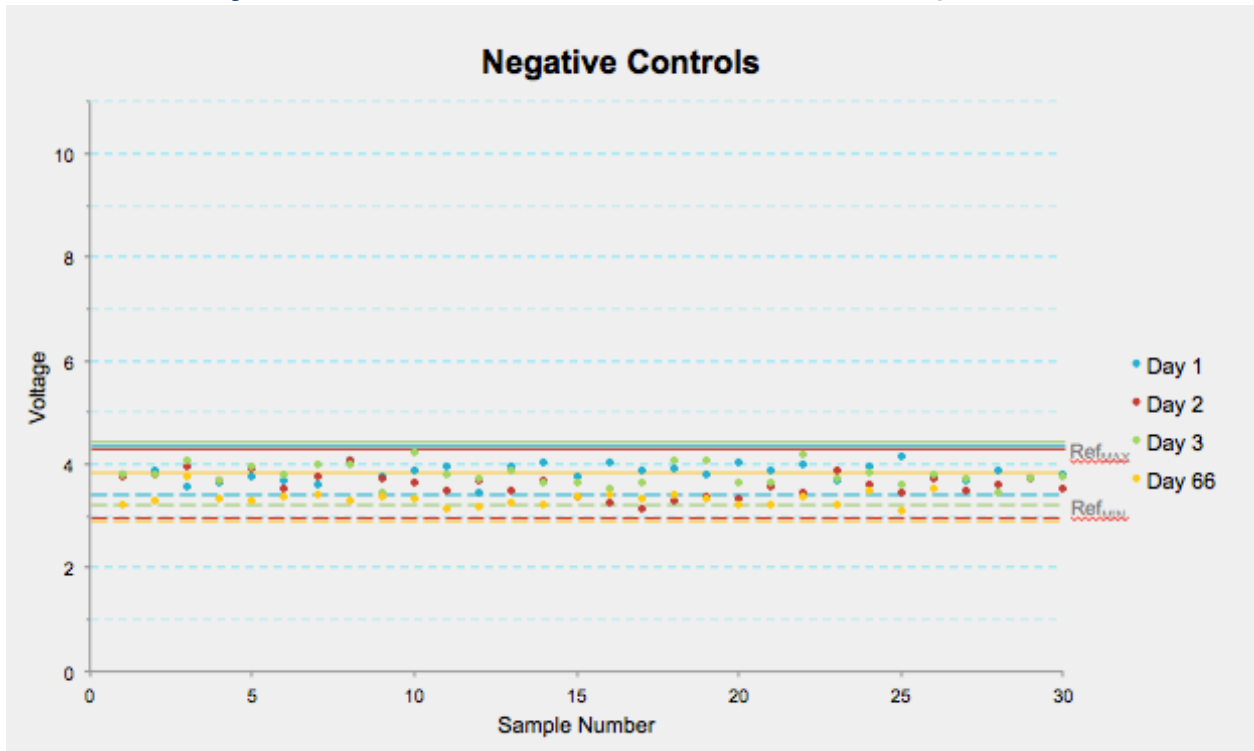
## Case Study 1: HVLD<sup>MC</sup> with Albumin Solution (1,2,3 and 66 days)

- ✓ 2R (4ml capacity) glass vials
- ✓ 13mm Teflon faced stopper, Flip Off Seal 13 mm
- ✓ Positive Controls: 5, 10 und 15  $\mu\text{m}$  laser drilled holes, neck and bottom
- ✓ 3 positive control samples of each hole size and position
- ✓ 4 rounds of testing; 3 consecutive days, and one round 66 days later in different locations (NY-CH).
- ✓ Fill volume was 3ml 20% Albumin solution for both PC and NC groups. Vials were filled prior to testing, stoppered and crimped.

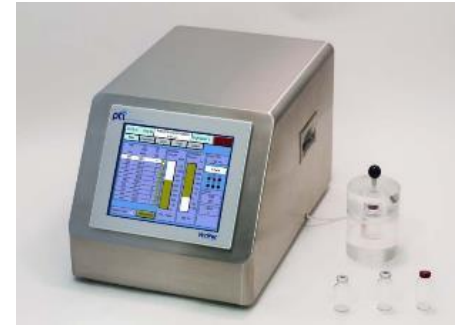
## Vacuum Decay

- Vacuum Decay @ <5.0mbar
- Albumin & Water Samples
- Laser Drilled Defects 5, 10, and 20 $\mu$ m.

- **Vacuum decay is a sensitive and reliable test method for gas applications**
- **Reliability and capability of Vacuum decay is adversely affected by large molecule products such as Albumin, producing a low to zero detection capability for protein base solutions**
- **MicroCurrent High Voltage Leak Detection (HVLD<sup>mc</sup>) is capable of detecting micro cracks down to the MALL, including for low conductivity liquids**
- **HVLD<sup>mc</sup> is not time critical (time zero vs. day 66).**
- **MicroCurrent HVLD<sup>mc</sup> generally effective for wide range of product conductivities.**
- **Naturally occurring defects below the 1µm level can be readily detected using HVLD<sup>mc</sup>**
- **Nonvisible cracks below the crimping are detectable**

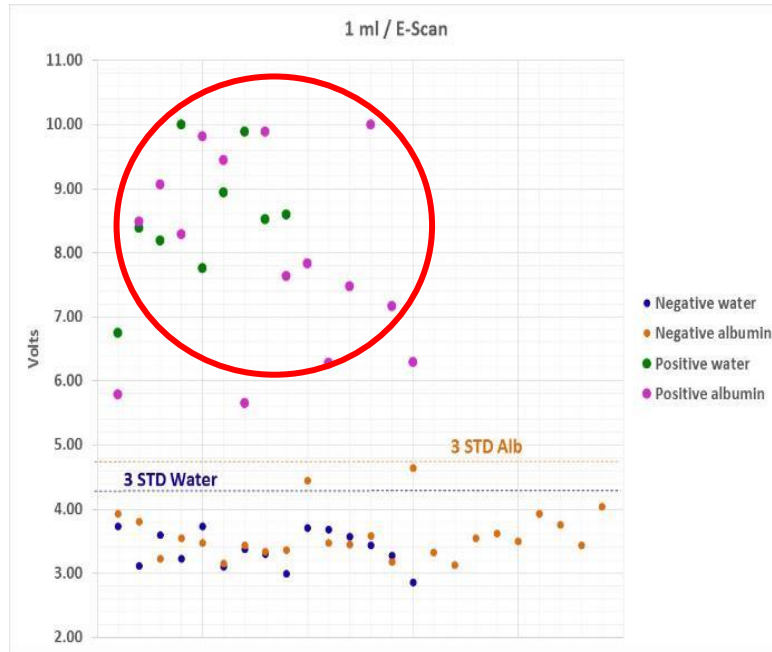
# HVLD<sup>mc</sup>

HVLD shows a clear advantage in detecting defects in parenteral packaging containing large molecule products.

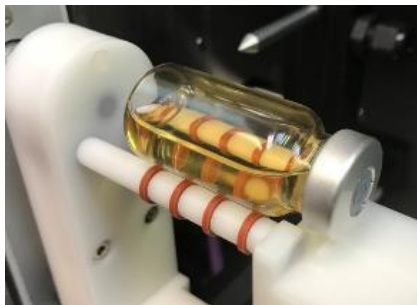
- ❖ Controlled crack produced.
- ❖ Certified flow measurement with Helium mass spec.
- ❖ Peak signal response is recorded.
- ❖ Voltage signal response with each rotation.

He Certified Leak Rate	
95.0	10 <sup>-5</sup> mbar·l/s
0.05700	sccm
2.67	~µm

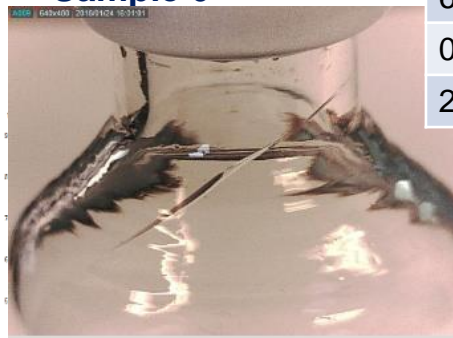
**Sample 6**

**He Certified Leak Rate**

67.0	$10^{-5}$ mbar·l/s
0.04020	sccm
2.24	$\sim\mu\text{m}$

**10.0V**

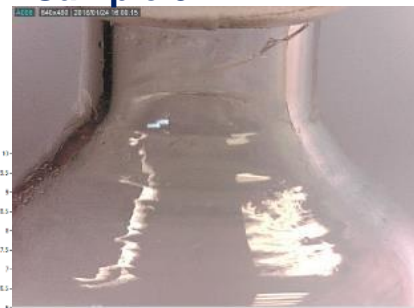
**Sample 3**

**He Certified Leak Rate**

29.0	$10^{-5}$ mbar·l/s
0.01740	sccm
1.47	$\sim\mu\text{m}$

**10.0V**

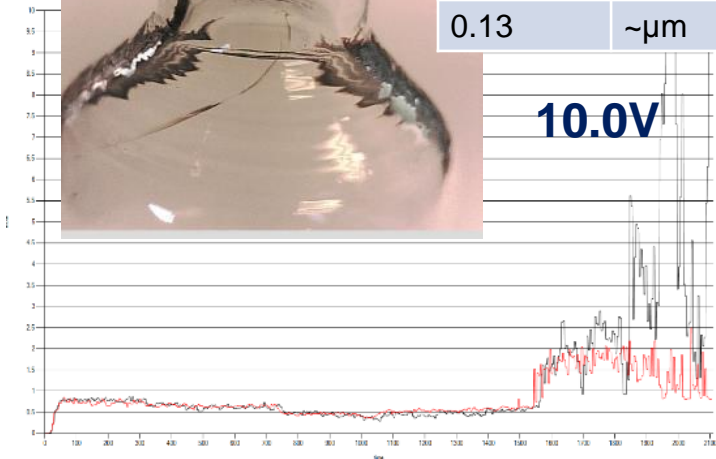
**Sample 2**

He Certified Leak Rate	
0.21	10 <sup>-5</sup> mbar·l/s
0.00013	sccm
0.13	~μm

**10.0V**
