## Machine use of glass primary packaging material

*Klaus Ullherr, Senior Product Manager, Bosch Packaging Technology, Pharma liquid*

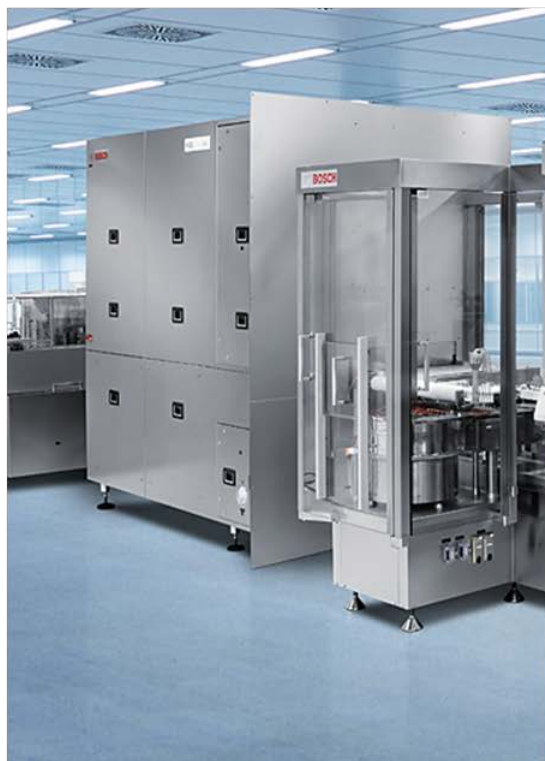
Cartridge processing,  
Sterilizing tunnel.  
Heating of glass containers  
up to 300 degrees Celsius

- Direct **glass to glass contact** within the system
- **Pressure** on containers in tunnel infeed section
- Heating of glass containers up to **>300 degrees Celsius**
- → Reduction/destruction of the **water skin** of the glass → sticky containers, scratch sensitive containers

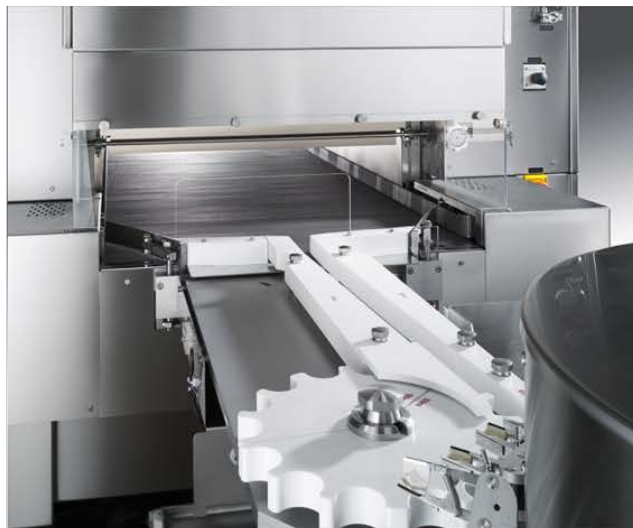
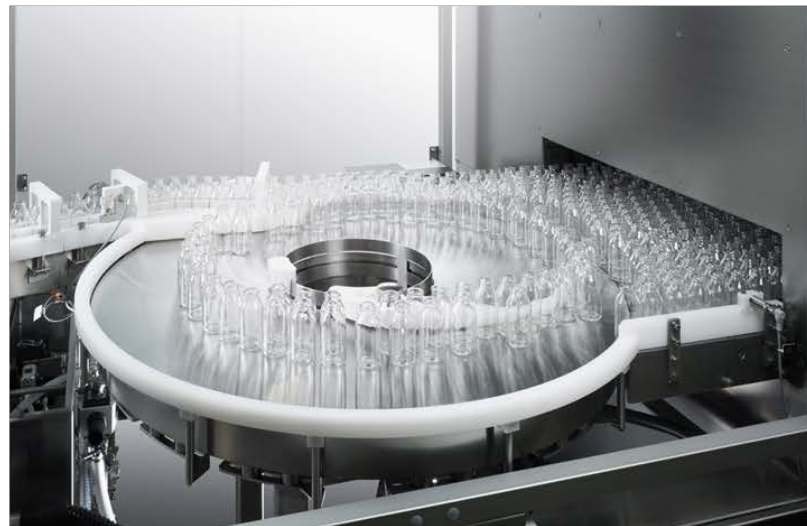
- Accumulation control with bulk infeed, bulk transport and bulk discharge

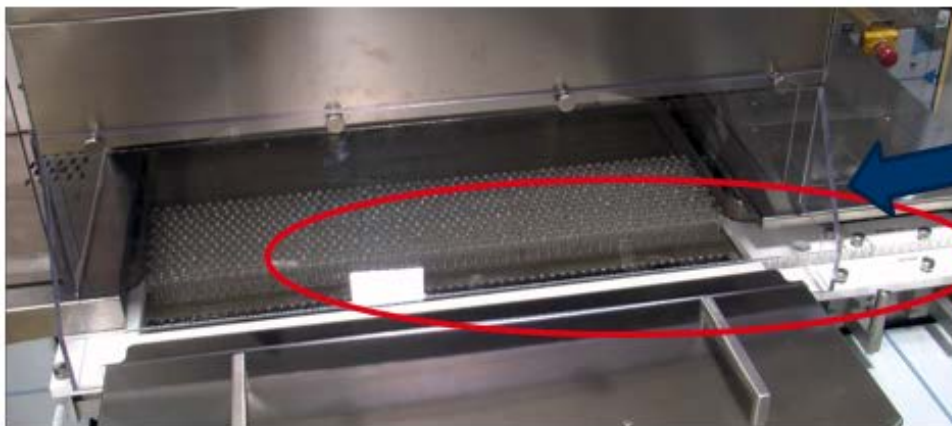
→ Three Belt System: Main belt and side belts movement is synchronized

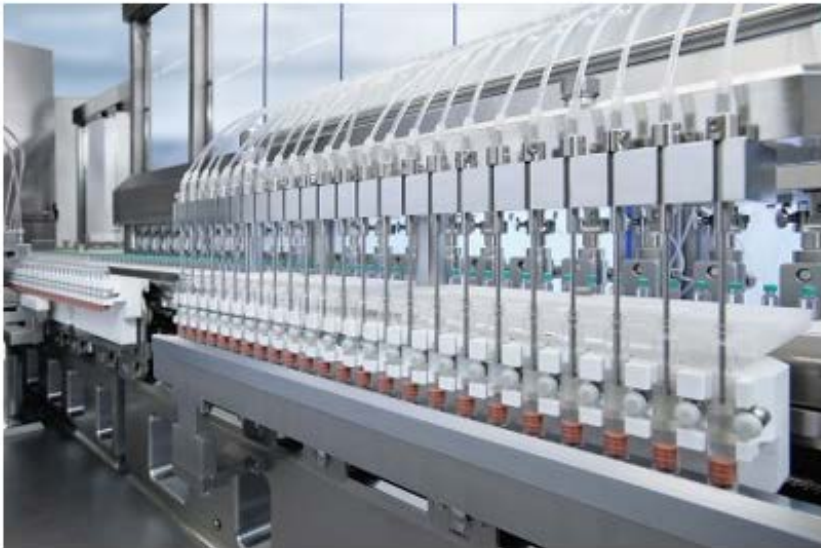
### Carrier System:

- **Precise and individual** transportation through the Filling and Closing Machine

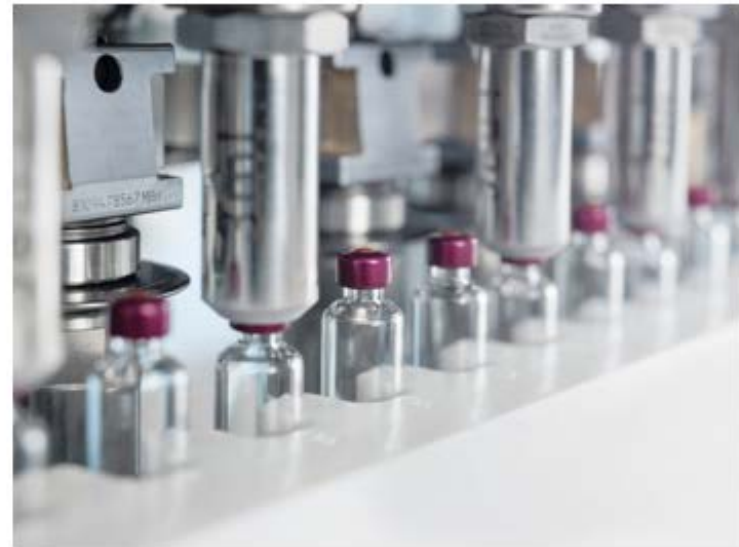
### Closing:

- Adjustable pressure and slight rolls
- Cartridge is rotated from both ends

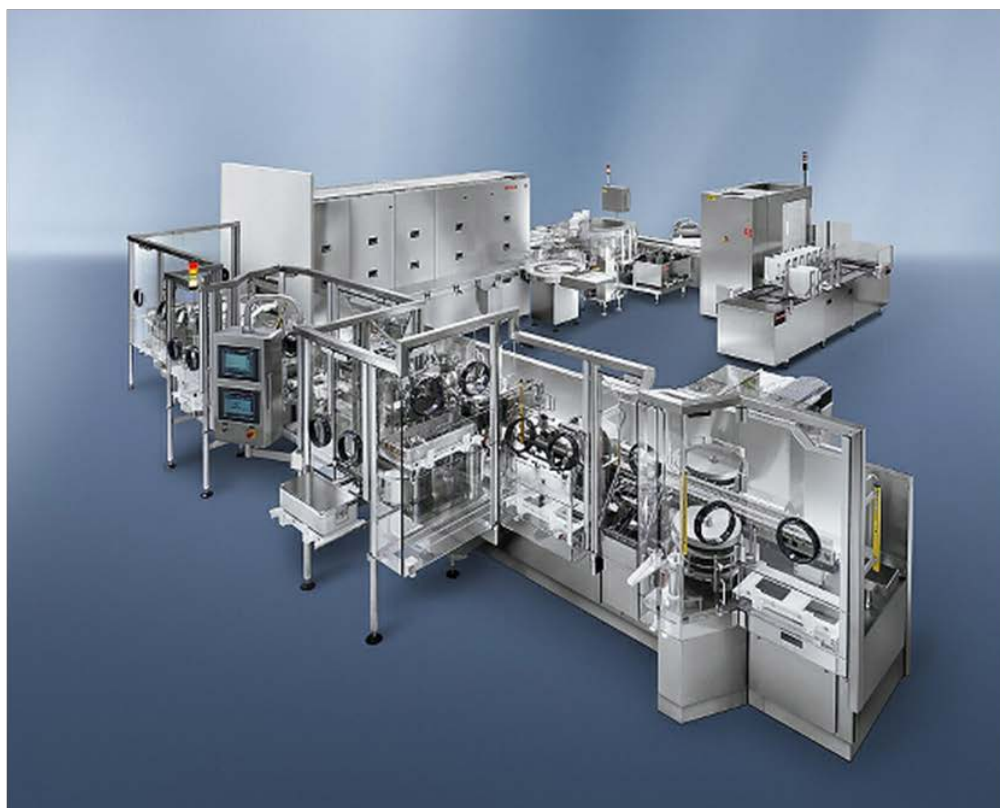
Line without any  
glass to glass contact

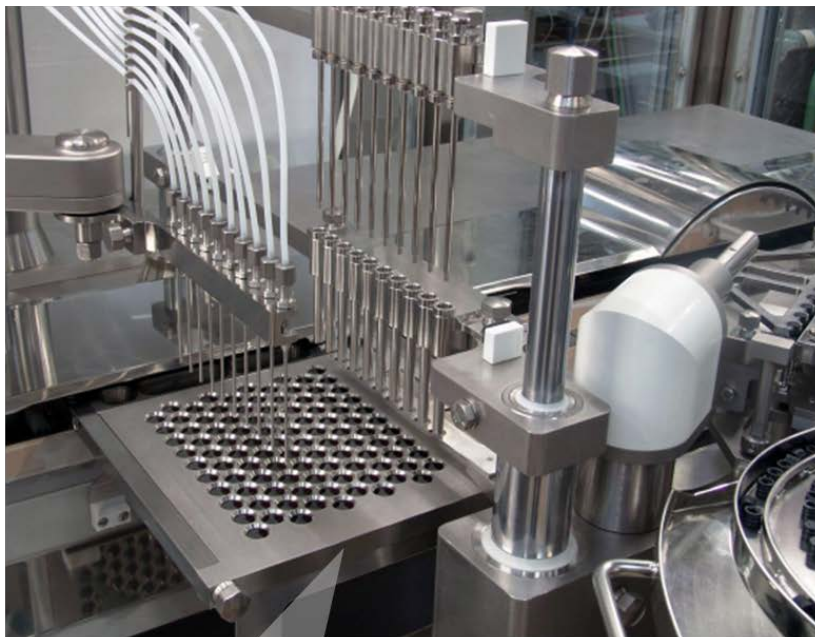
Centering plate  
stainless steel

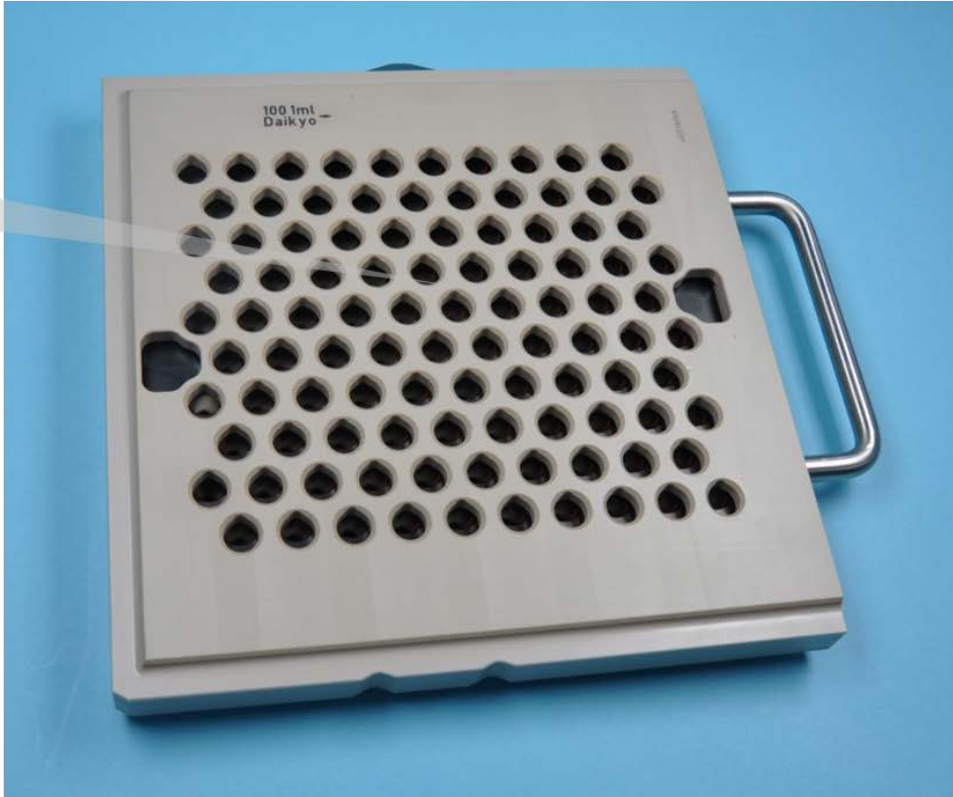
Centering plate  
plastic material

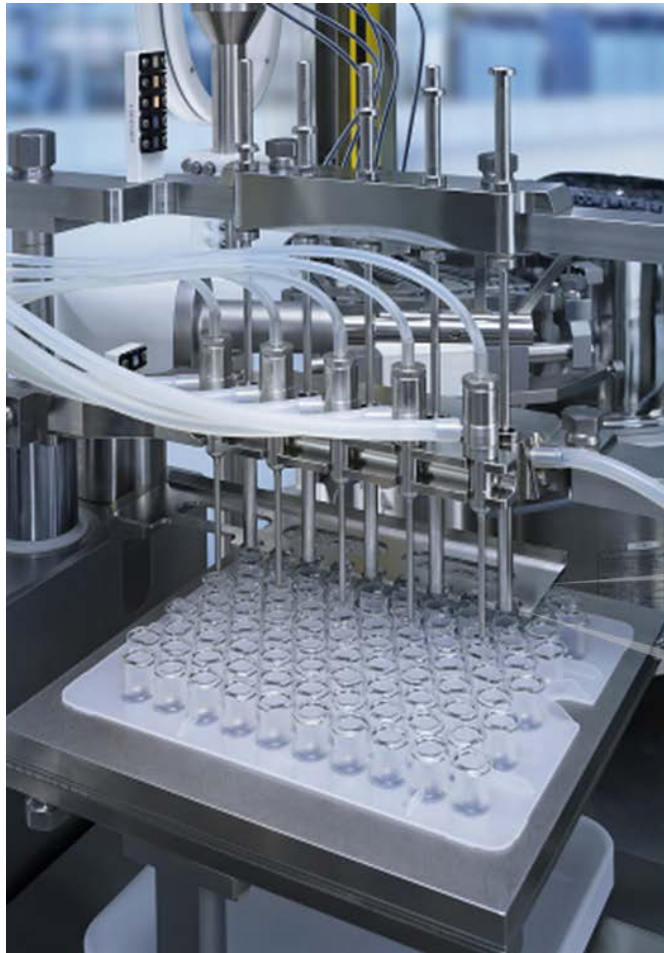
Insertion tubes

Filling needles
